# Building Enclosure Warranty Review

The Taylor, 550 Taylor Street, Vancouver, BC

REPORT 2688.00

DATE May 7, 2007

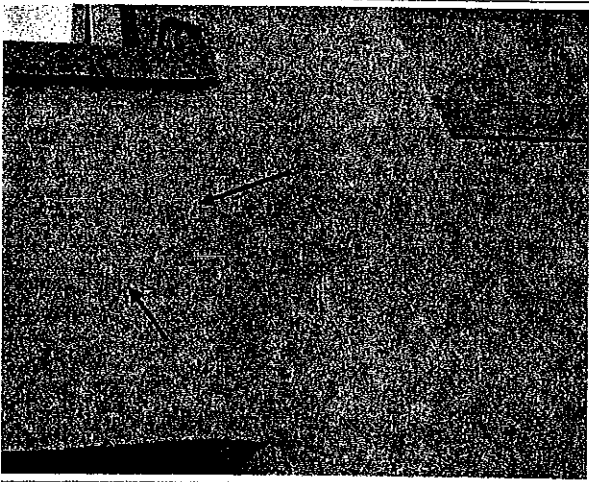
1. Cracks in the concrete, typically at construction joints (Fig. 2.1.1.1, Fig. 2.1.1.2). The architectural details indicate the use of waterstops to help reduce water ingress, however we could not confirm if they had been installed. **Significance:** May lead to water ingress. Reveals should have been incorporated at construction joints to allow easier installation of sealant.

Figure 2.1.1.1. - Cracks in the architectural concrete at the ground floor level.

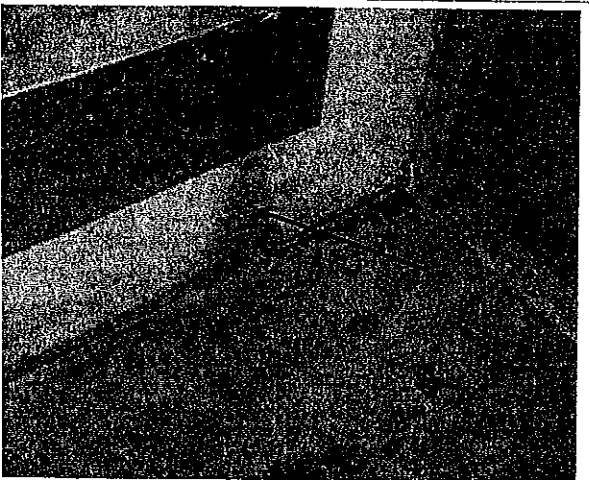
2. Evidence of past water ingress at elevator penthouse concrete wall cracks (Fig. 2.1.1.3). Remedial sealant has been installed over the cracks on the exterior of the concrete. **Significance:** Water ingress may reoccur; therefore the situation must be monitored.

Figure 2.1.1.3. - Evidence of water ingress in mechanical room.

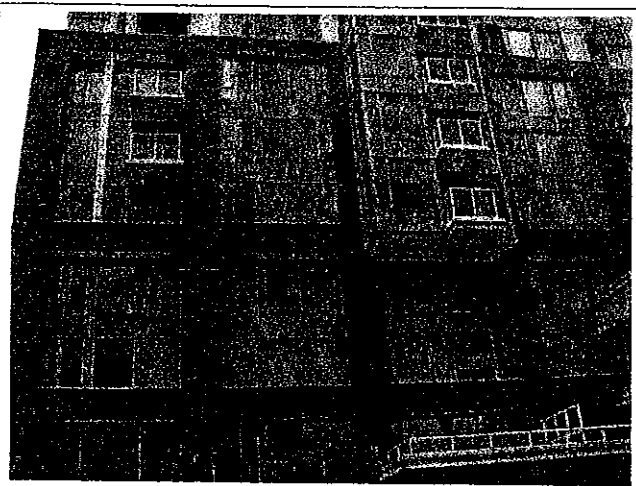
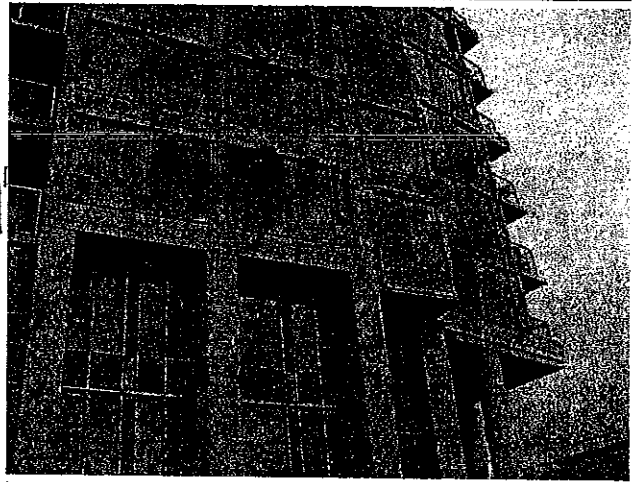
4. Insulation appears to be missing at numerous soffit locations (Fig. 2.1.1.4). Suite 510 reported cold floors at these areas. See also 2.3 Balconies. **Significance:** Incomplete thermal barrier, resulting in higher energy usage, possible condensation at windows, and possible uncomfortably cold floors in the winter.

Figure 2.1.1.4. - Missing insulation at soffits.

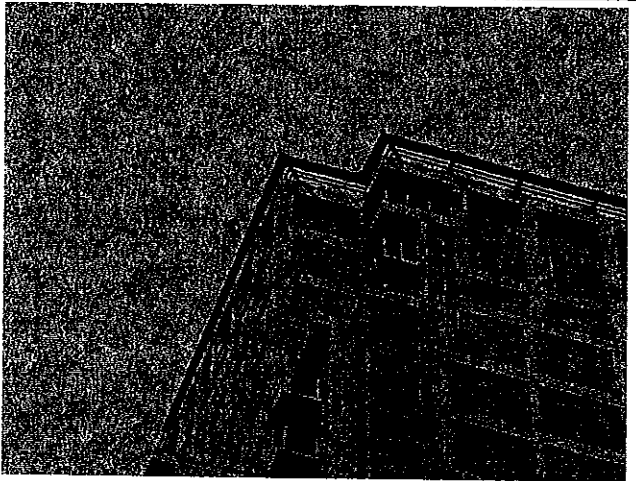
5. Suite 2701 reported concrete missing from suite above. There appears to be concrete missing from under the planter (Southwest planter, South elevation) cap flashing of Suite 2801 (Fig. 2.1.1.5). **Significance:** If the concrete spalled from the building, this would be a hazard to people/property. Reasons for the missing concrete should be reviewed with the original design team.

Figure 2.1.1.5. - Apparent missing concrete at Suite 2801.

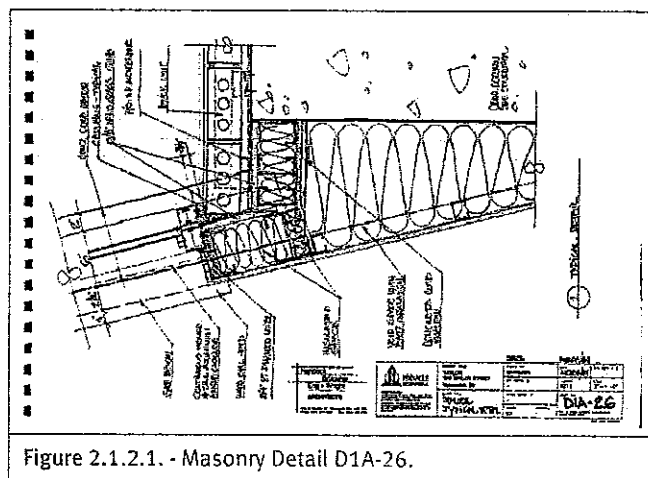
1. Detail D1A-26 (Fig. 2.1.2.1) illustrates a situation at the high-rise where lightweight steel framing has been used to frame in areas between structural concrete and windows. This wall is similar to Assembly 1, but instead of concrete there is sheathing. **Significance:** The self-adhered membrane on the sheathing has low vapour permeance; therefore there exists the possibility of condensation on the sheathing. A risk for deterioration exists because sheathing is less durable than concrete. It may have been

preferable to use a more permeable sheathing membrane than the self-adhered membrane shown. However, we could not confirm what the as-built condition was, we recognize that these areas may be limited, and the transitions between window/sheathing and sheathing/concrete required self-adhered membrane stripping, therefore limiting the area for vapour permeable sheathing membrane. Exploratory openings should be made at select locations to check the condition of the sheathing within 5 years.

Figure 2.1.2.1. - Masonry Detail D1A-26.

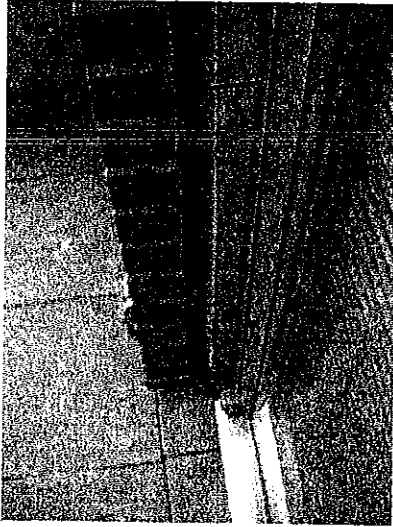
2. Significant gaps between masonry and adjacent wall components (SE corner of courtyard, Suite 506 deck) (Fig. 2.1.2.2). **Significance:** Incomplete finishing, an opening for water and pest entry.
3. Missing sealant at some horizontal expansion joints, for example, near parking garage ramp on west elevation and on north elevation (Fig. 2.1.2.3). **Significance:** Incomplete finishing, an opening for water and pest entry.
4. Missing sealant around canopy anchor over the parking garage ramp (Fig. 2.1.2.4). **Significance:** Incomplete finishing, an opening for water and pest entry.
5. Unsupported masonry veneer at the east elevation, northeast corner (Fig. 2.1.2.5). **Significance:** May be a hazard to people/property. The original design team should review the situation.

Figure 2.1.2.2. - Gaps between masonry and adjacent wall components (e.g. SE corner of courtyard, Suite 506 deck).

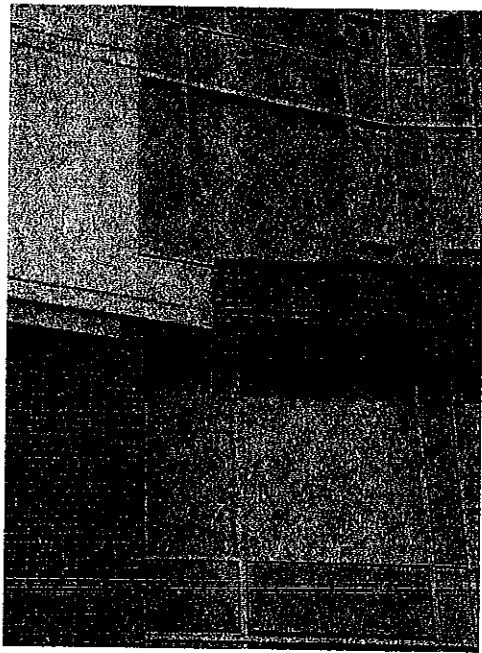
Figure 2.1.2.5. Unsupported masonry at the east elevation northeast corner.

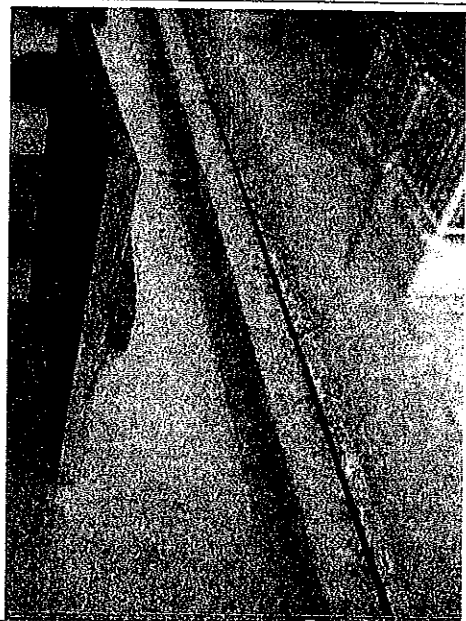
1. Condensation at windows was reported at many suites, primarily at the townhouses (Fig. 2.2.1.1). The situation was reportedly worse in colder weather and with the windows closed. Ventilation, especially at the townhouses, may not be adequate for the occupants' needs. **Significance:** Damage to interior finishes, fungal growth, and a nuisance to occupants. Increased air circulation will reduce condensation and the likelihood of fungal growth. Periodically opening windows, using bathroom and kitchen fans, and leaving open drapes and blinds, may improve the situation. The original design team should review the situation.

Figure 2.2.1.1. - Condensation and fungal growth at Townhouse 18.

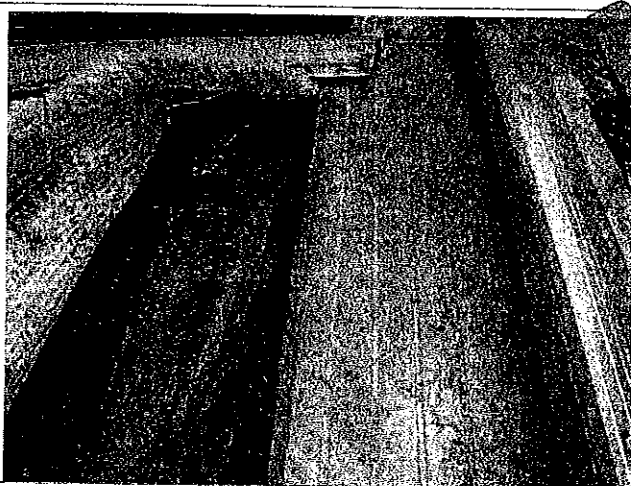
1. Many townhouse occupants reported water ingress at door thresholds. We reviewed Townhouses 4, 6, 7, and 8; all of these townhouses have a front door at street level and a rear door to the courtyard. All the rear doors we reviewed had evidence of past water ingress (Fig. 2.2.2.1) because of the lack of canopies above. **Significance:** Damage to interior finishes, fungal growth, and a nuisance to occupants.
2. Front doors to townhouses at street level had less evidence of water ingress because of the canopy above. But there is a gap between this canopy and the building (Fig. 2.2.2.2). Architectural Detail D2B.06 indicates that a flashing should have been installed. **Significance:** Damage to interior finishes, fungal growth, and a nuisance to occupants.

Figure 2.2.2.1 - Evidence of water ingress at Townhouse 4 rear door.

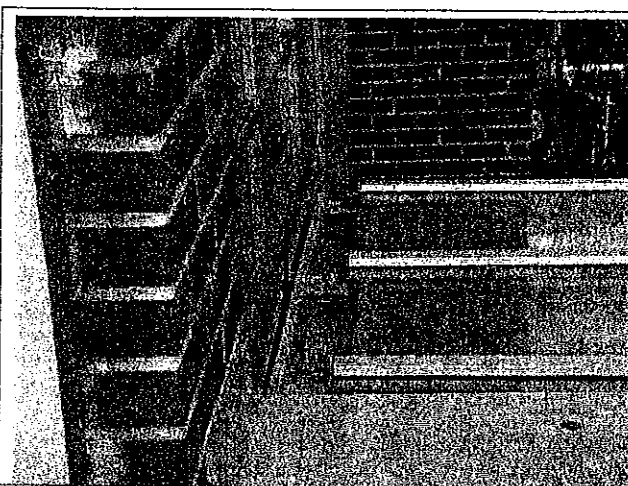
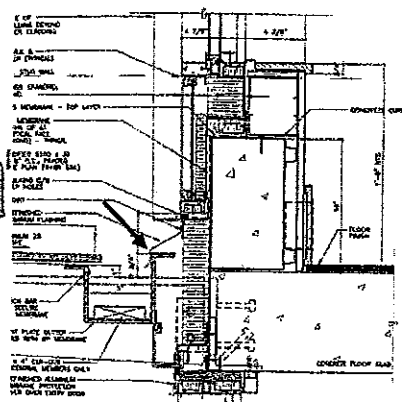
Figure 2.2.2.2. - Townhouse canopies do not have a transition flashing at gutters. Note that Detail D2B.06 shown above has the flashing indicated.

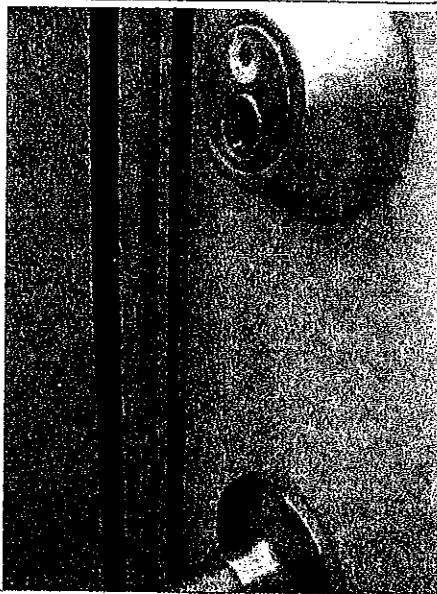
At many townhouse doors there is air leakage because the weather-stripping is not tight to the doors (Fig. 2.2.2.3). At some high-rise suites, occupants complained of drafts at the balcony doors. **Significance:** Energy loss, lack of comfort.

Figure 2.2.2.3. - Poorly fitted weather-stripping at Townhouse 4 rear door.

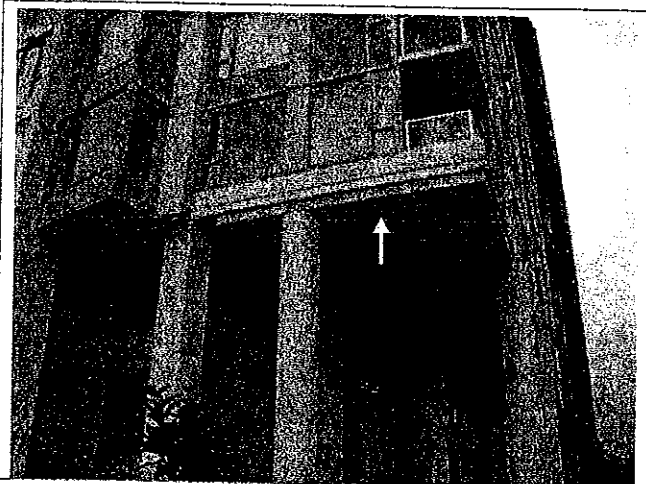
1. Reported cold floors at enclosed balconies of Suite 510 (Fig. 2.3.1) and townhouses (Fig. 2.3.2). Enclosed balconies are not considered occupied space; therefore there are no requirements for insulation (although the walls between the enclosed balcony and the suite must be insulated). However, some enclosed balconies (Suite 503) have soffit insulation and were detailed that way (Fig. 2.3.3 - Detail D1B-19A). Further to this, there are electric baseboard heaters in the enclosed balconies of Suite 510 and the townhouses we had access to (Townhouses 18 and 20), indicating that they may be considered occupied space, but they have no soffit insulation. See also 2.1.1 Architectural Concrete, item 4. **Significance:** Uncomfortably cold floors in the winter, virtually rendering the space unusable. Condensation at windows.

Figure 2.3.1. - No soffit insulation at Suite 510 enclosed balcony (red arrow). Note the soffit insulation at the adjacent area (yellow arrow).

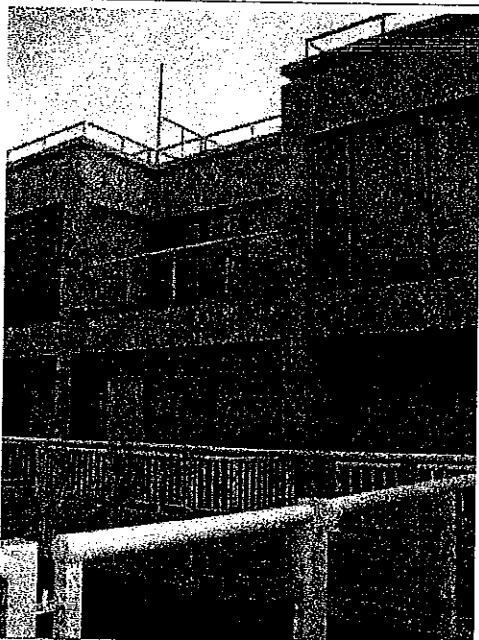
Figure 2.3.2. - No soffit insulation at townhouses.

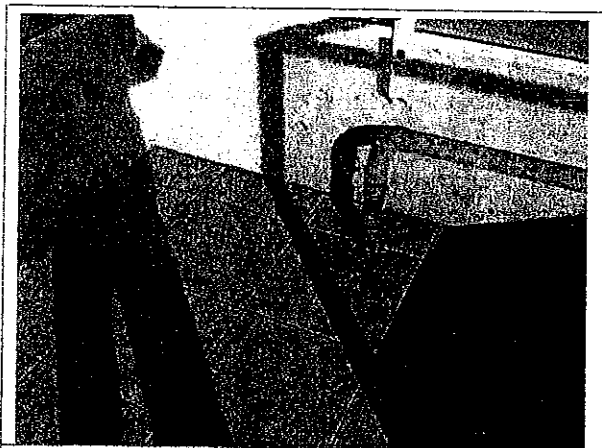
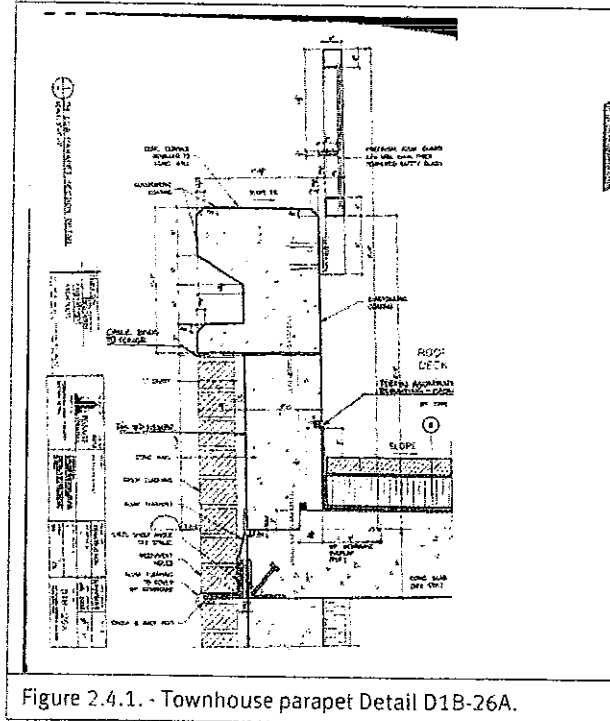
1. The as-built condition townhouse parapet detail varies from Detail D1B-26A (Fig. 2.4.1) in that there is no precast cornice with continuous waterproofing underneath (the cornice is poured-in place concrete instead, not precast), and the waterproofing membrane is not terminated 3" above the paver level. **Significance:** As-built detail is less reliable from a waterproofing perspective. Water staining on the ceiling in Townhouse 17 (252-35 Keefer Place) has been reported. Water ingress has been reported at Townhouse 19 (257-35 Keefer Place).

Figure 2.4.1. - Townhouse parapet.

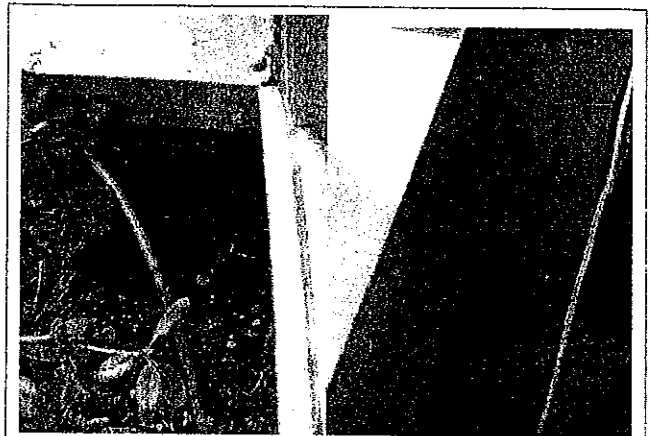
2. Evidence of past water ingress in master bedroom of Suite 1607 (Fig. 2.4.2). The origin of the water ingress is likely the planter on the deck outside. The planter has been partially excavated, however it is unclear if remedial work was conducted. The termination of the membrane lacks a reglet, base flashing, and sealant, as shown on Architectural Detail D1B.03. **Significance:** A nuisance to occupants, damage to interior finishes, and may lead to deterioration of moisture sensitive building components and fungal growth.

Figure 2.4.2. - Evidence of past water ingress at Suite 1607.

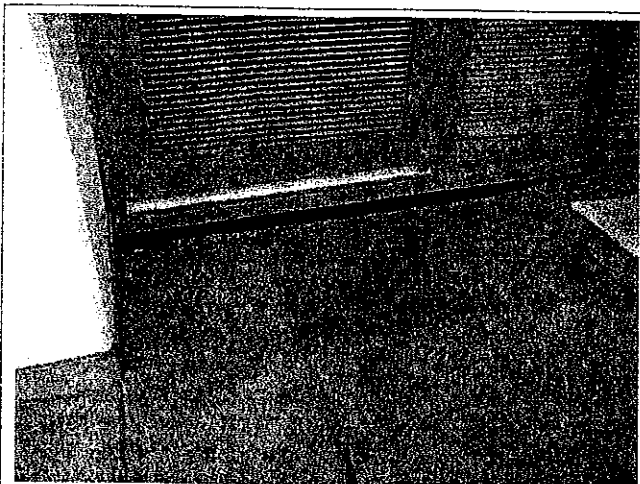
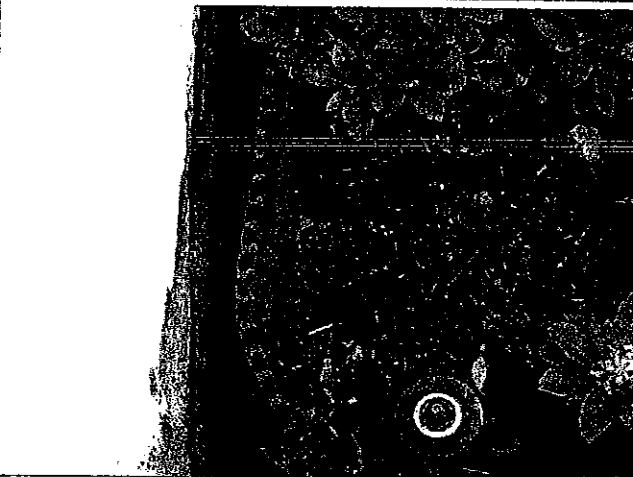
1. Exposed waterproofing membrane at the base of high-rise in the courtyard and at planters (Fig.2.5.1.2). The membrane must be covered at all locations. The terminations in the planters are missing a reglet, base flashing, and sealant, as shown on Architectural Detail D1B.03. **Significance:** Will result in premature deterioration of the membrane.
2. Missing sealant at metal flashing gum lip termination in the courtyard (Fig.2.5.1.3). **Significance:** May result in water ingress behind the waterproofing membrane.

Fig. 2.5.1.2. - Exposed waterproofing membrane at the courtyard.

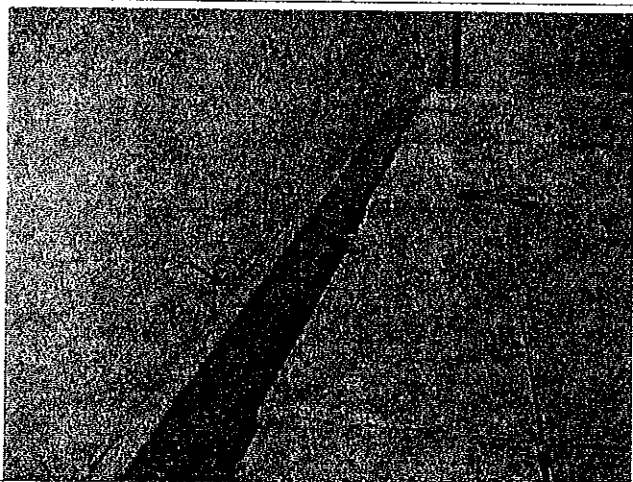
Fig. 2.5.1.3. - Missing sealant at metal flashing gumlip termination.

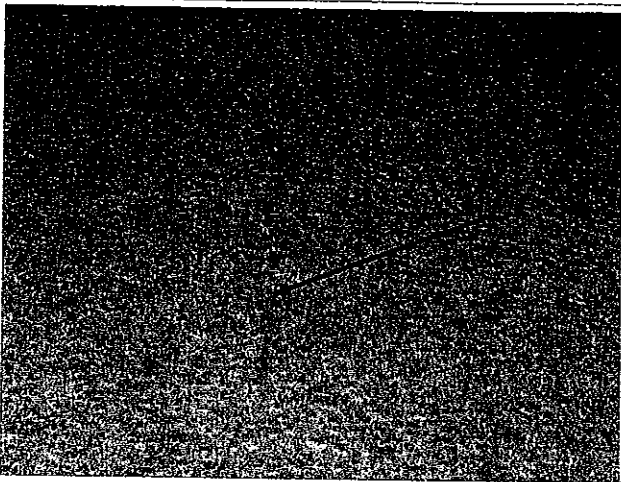
1. Various cracks in the polyurethane liquid-applied traffic membrane on suspended slabs (Fig. 2.5.2.1). Water ingress reported at various locations, including above Stalls 205, 319, and P3 elevator entrance door. **Significance:** Water ingress into the parking level below is a nuisance for parkade users, may damage automobiles, and may lead to corrosion of the reinforcing steel over the longterm.

Figure 2.5.2.1 - Cracks in the liquid- applied traffic membrane at P2.

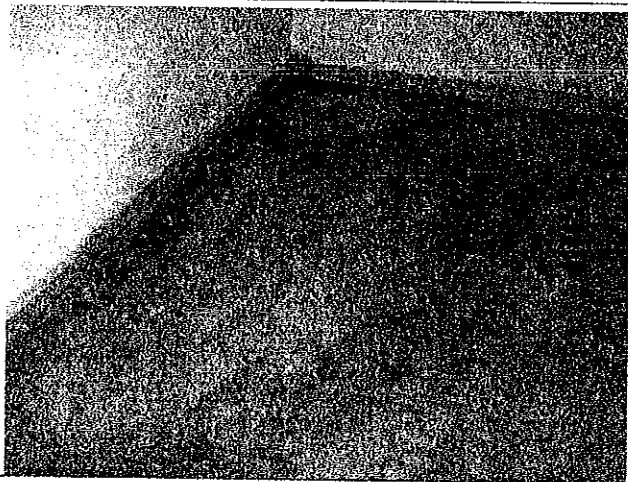
2. Ponded water at various stalls (e.g. 147, 225, 235, 272 (Fig. 2.5.2.2)). **Significance:** A nuisance to parkade users.
3. Water ingress through foundation walls at Stalls 247 (Fig. 2.5.2.3) and 169, and at ground floor, northeast stairwell (Stair #6). **Significance:** A nuisance to parkade users, and may lead to corrosion of the reinforcing steel over the longterm.

Figure 2.5.2.2 - Ponded water in Stall 272.
